ARCCA, INCORPORATED
146 N CANAL STREET, SUITE 300
SEATTLE, WA 98103
PHONE 877-942-7222 FAX 206-547-0759
www.arcca.com

Re: *Brad Norman vs. Travelers Indemnity Company*
ARCCA Case No.: 3601-026
Case No.: 20-2-10988-6 SEA

Damage and Incident Severity:

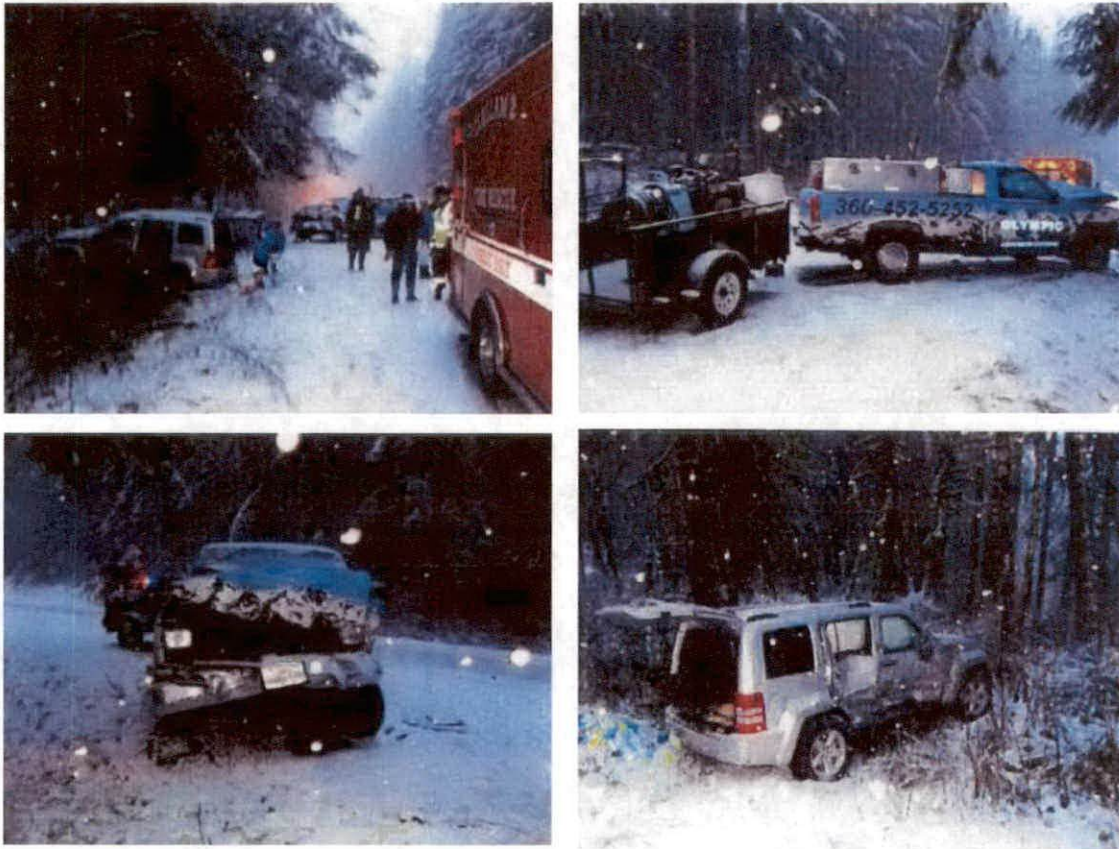
Figure 1: Scene and vehicle photographs included in the Investigator's Traffic Crash Report

truck bed, and was towing a trailer filled with equipment. The narrative states “*Huard-Hoffman, driving [the incident Jeep], lost control and began to fishtail while traveling uphill. [The incident Jeep] crossed the center line and was headed into the ditch when [the subject Chevrolet] struck it on the passenger side*”. The incident Jeep subsequently collided with the road’s ditch. Combination airbag deployment was noted for the incident Jeep; the subject Chevrolet was not equipped with airbags. Both vehicles were towed from the scene.

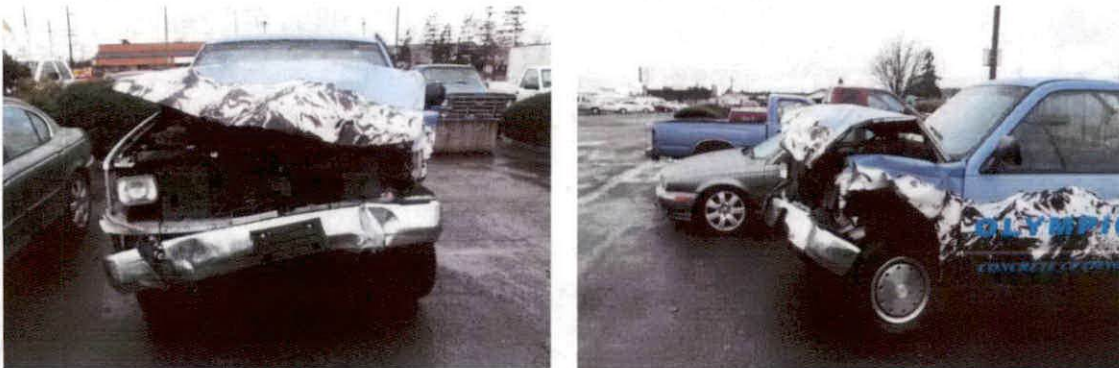
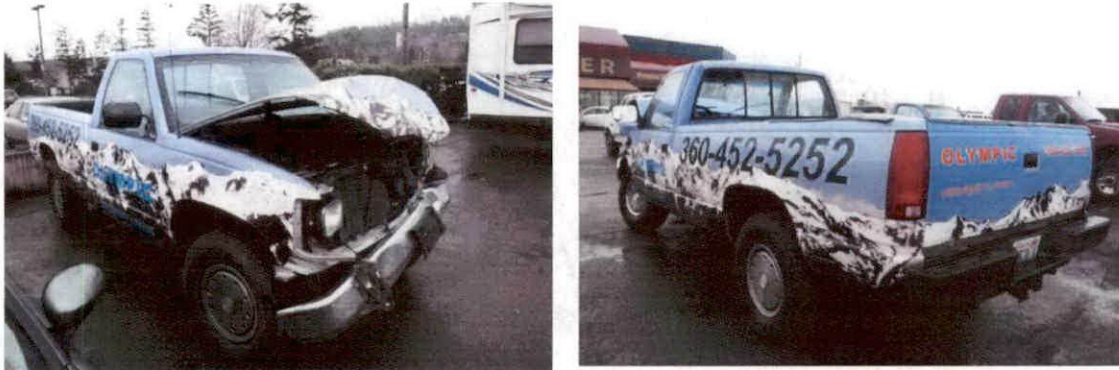
Figure 2: Photographic reproductions of the subject 1989 Chevrolet C2500

The photographs for the subject Chevrolet depicted damage to the front of the vehicle concentrated on the driver's side (Figure 2). The photographs for the incident Jeep showed primary damage to the passenger side between the wheels above the rocker panel (Figure 3).

Energy-based crush analyses have been shown to represent valid and accurate methods for determining the severity of automobile collisions.^{13,14,15,16,17} Analyses of the photograph and geometric measurements along with the repair record of the subject Chevrolet revealed the damage due to the subject incident. An energy crush analysis indicates that a single 32 mile-per-hour (mph) barrier impact to the front of an exemplar Chevrolet C2500 would result in significant and visibly noticeable crush across the subject Chevrolet's front structure, with a tapering residual crush of 0 to 42 inches (i.e., right to left of the subject Chevrolet's front).^{18,19} For reference, the distance from the front bumper to the base of the windshield is 54 inches. Thus, 42 inches is well in excess of the crush in the subject incident. This analysis is for the vehicle alone. If an additional weight of 1,000 pounds is accounted for the speed decreases to 29 mph for 42 inches of crush. It is expected that the weight of the loaded trailer and truck bed would weigh in excess of 1,000 pounds. Therefore, the energy crush analysis shows the subject Chevrolet underwent a Delta-V (the Delta-V is the change in velocity of the vehicle from its pre-impact, initial velocity, to its post-impact

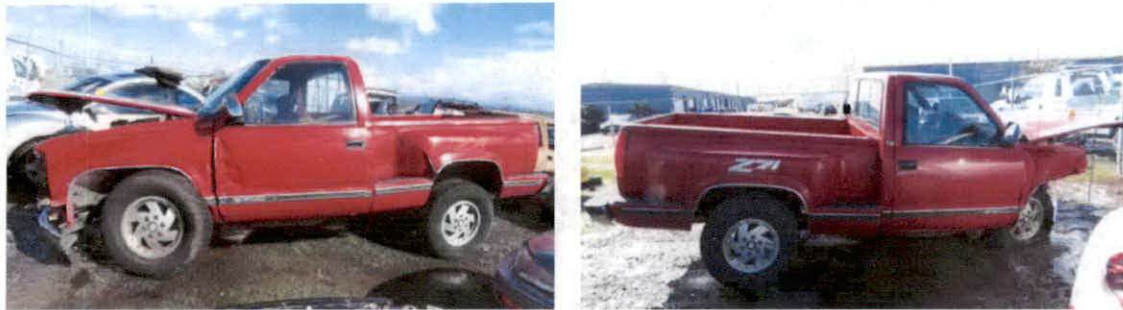
Figure 5: Photographic reproductions of a 1992 Chevrolet pickup truck involved in a front-end collision with a total Delta-V of 28.5 mph (CISS Case No. 1-33-2019-020-05)

The National Automotive Sampling System (NASS) and Crash Investigation Sampling System (CISS) investigate real-world automotive collisions and collect the data for use by NHTSA. Below are photographic reproductions involving collisions with exemplar Chevrolet pickup trucks and Jeep Liberty's.^{31,32} The post-impact damage from these real-world collisions was supportive of the conclusion that the subject Chevrolet experienced a frontal Delta-V of less than 30 mph (Figures
